# Third Five-Year Review Report

Hi-Mill Manufacturing Company  
Highland Township  
Oakland County, Michigan

September 2010

U.S. Environmental Protection Agency  
Region 5  
Chicago, Illinois

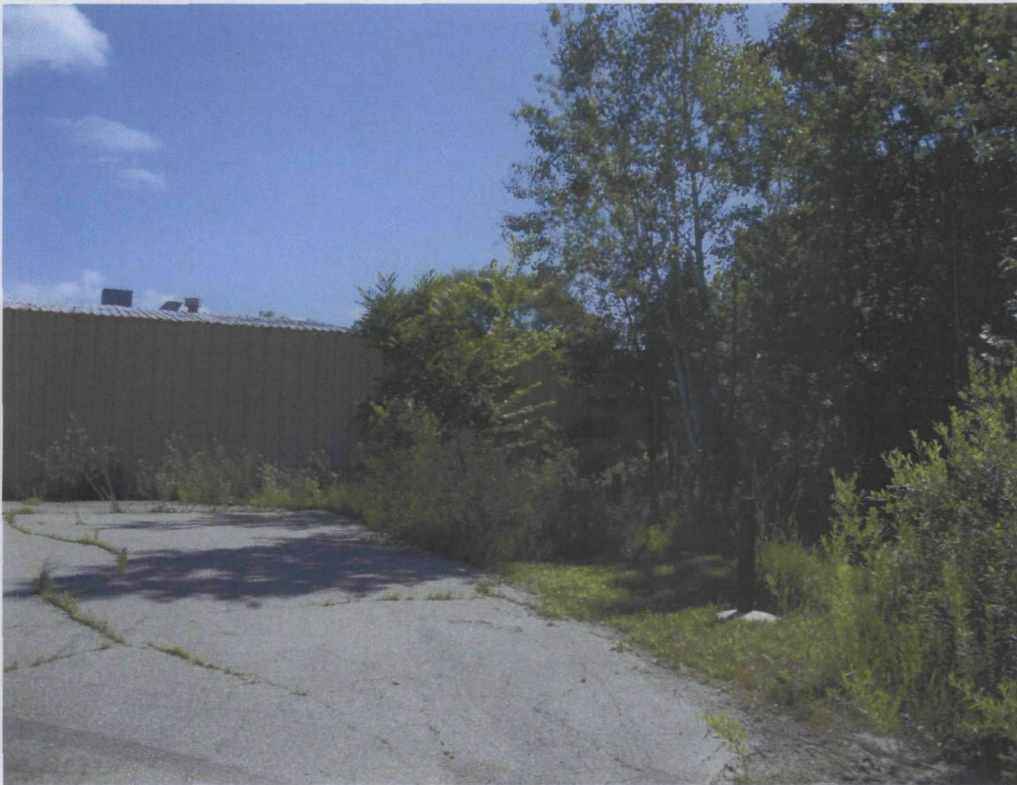
Photo 1: Looking north, southern side of facility with monitoring well in foreground.

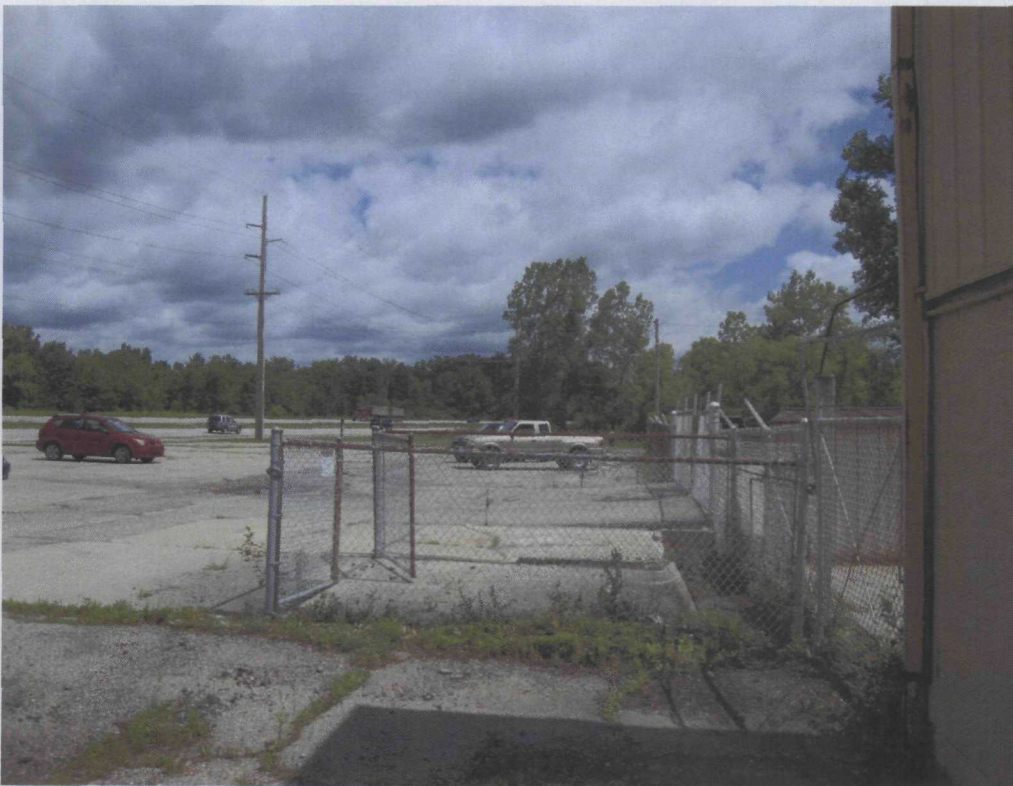
Photo 2: Looking north, northern side of facility with fence in foreground.

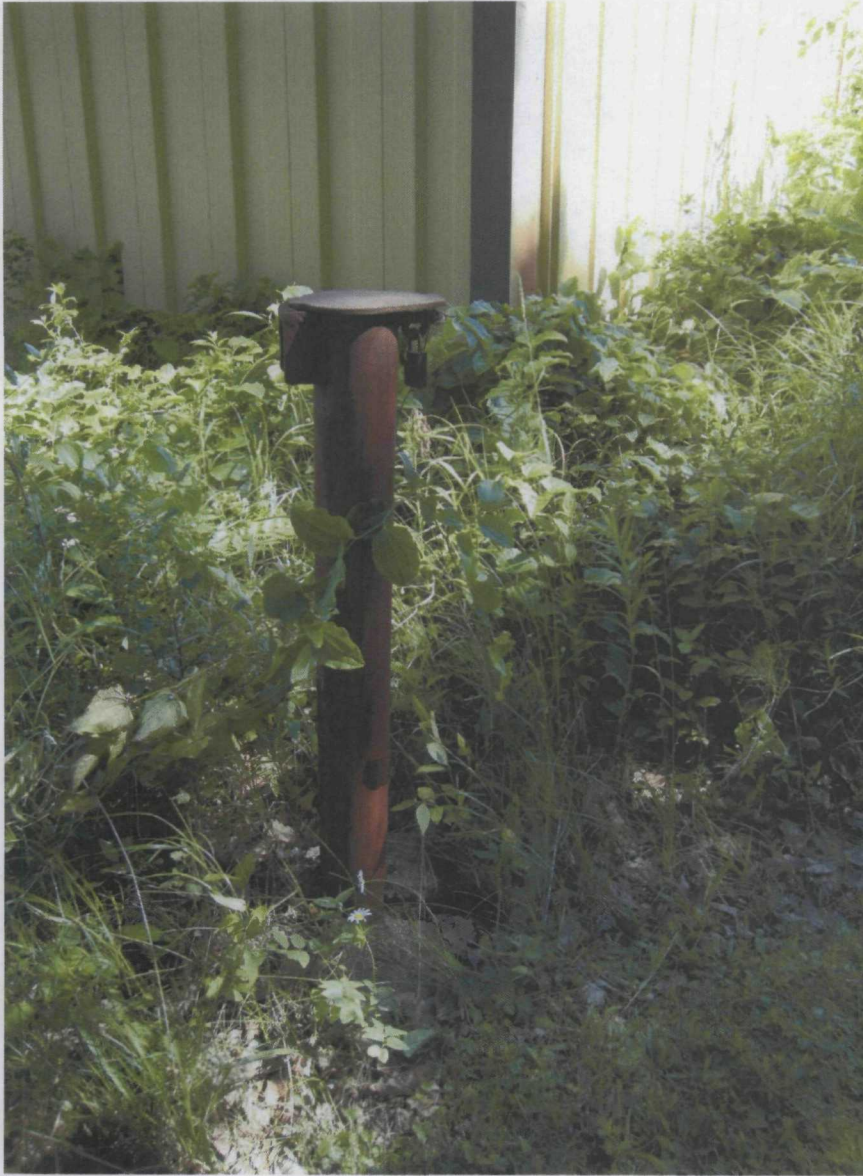
- The need for proper identification/location of all monitoring wells at the Site was identified. While Agency personnel were able to locate a majority of the monitoring locations, several locations were unable to be located based on maps provided in the Site's Operation and Maintenance Reports.
- Minor repairs are needed on several monitoring wells to ensure that they are properly secured.
- There is a need for the development of one comprehensive spreadsheet of all monitoring locations along with construction details (i.e., maps, well specifics, GPS coordinates, status of wells, etc.)

Photo 3: Unmarked monitoring well at rear of facility.

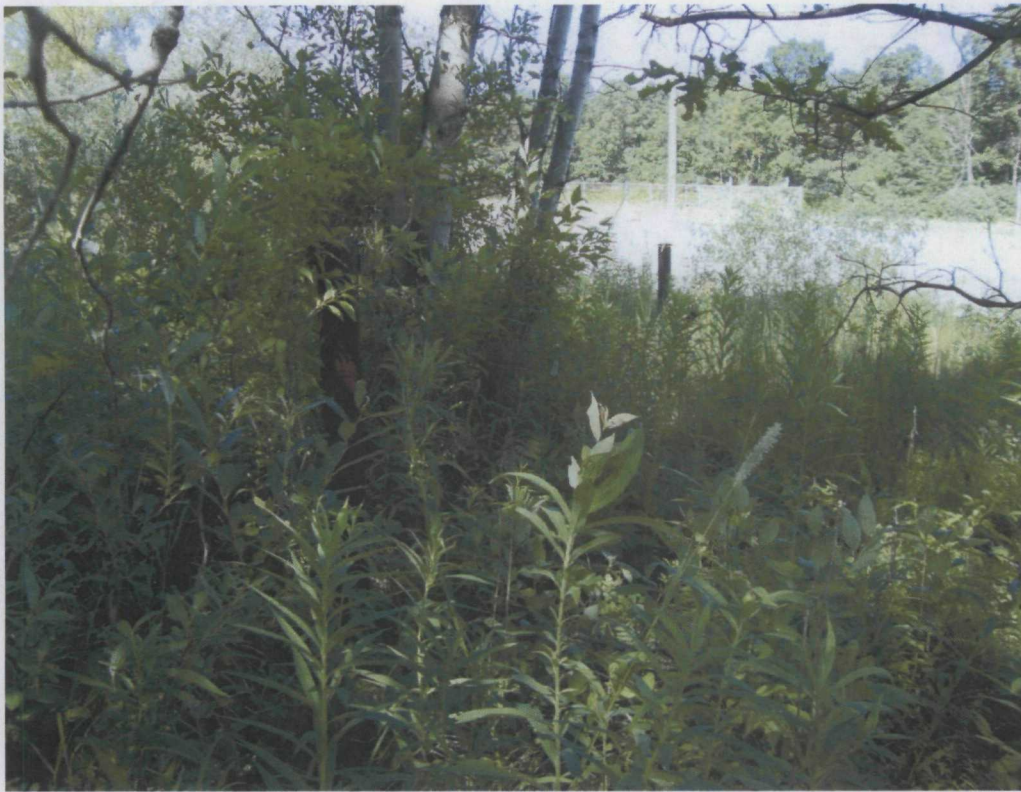
Photo 4: Example of excessive growth surrounding monitoring well.

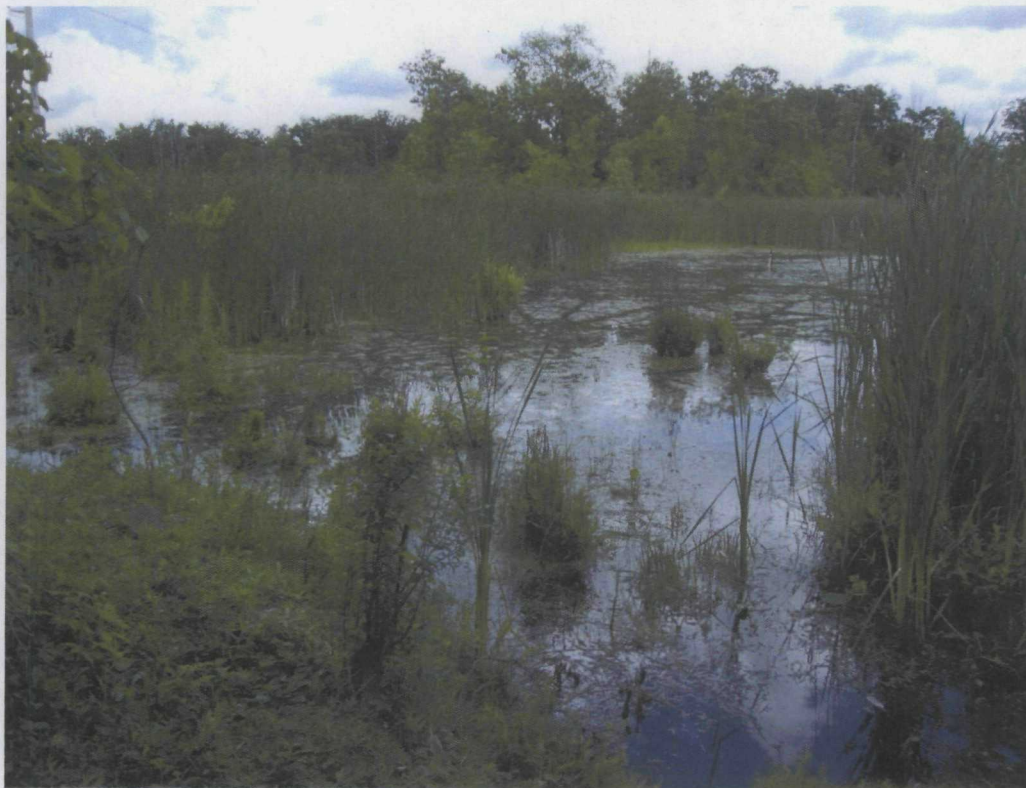
Photo 5: Target pond located east of facility.

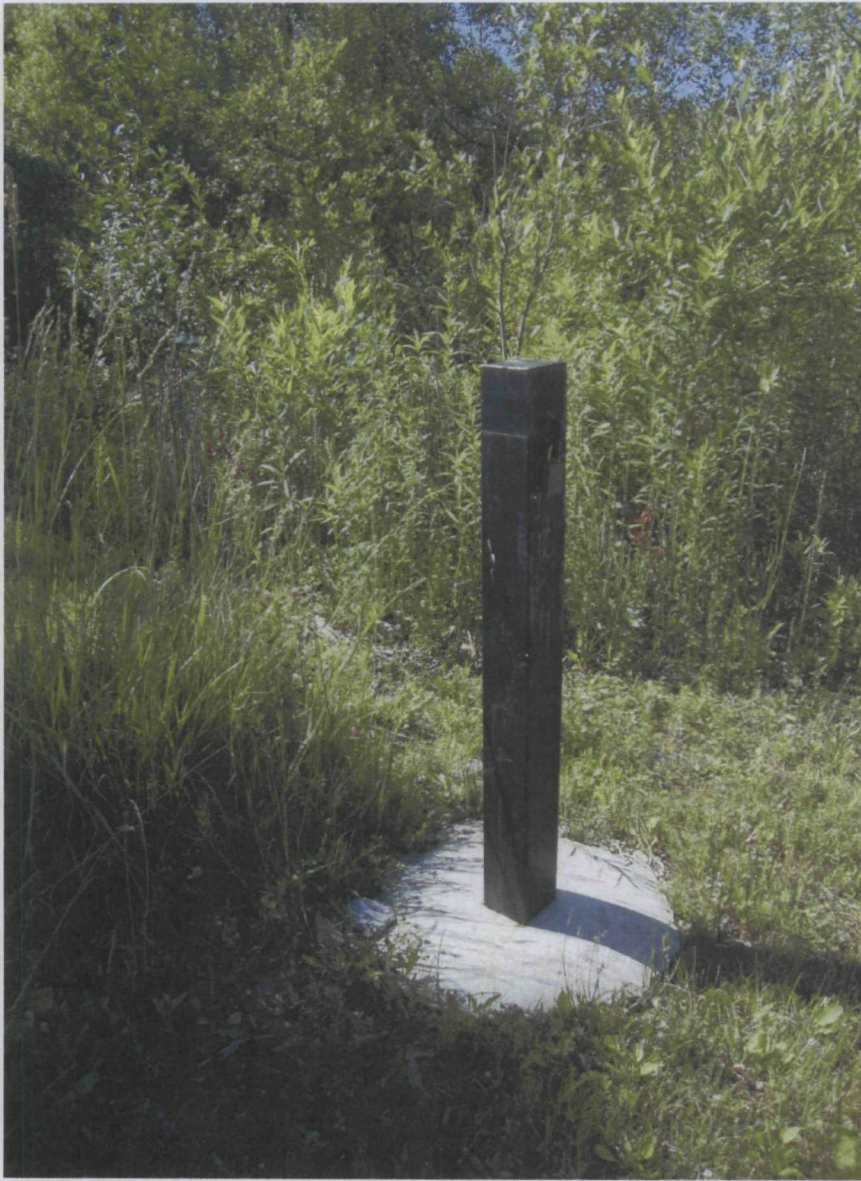
Photo 6: Example of monitoring well in good condition.

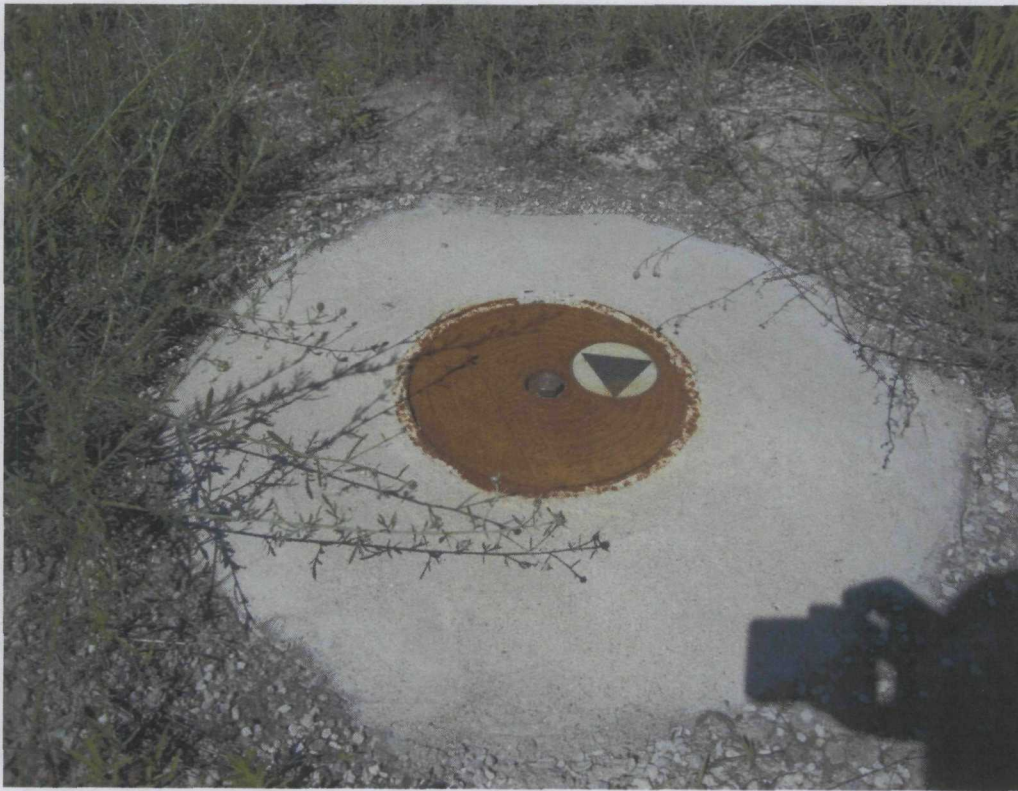
Photo 7: Example of flush monitoring well in good condition

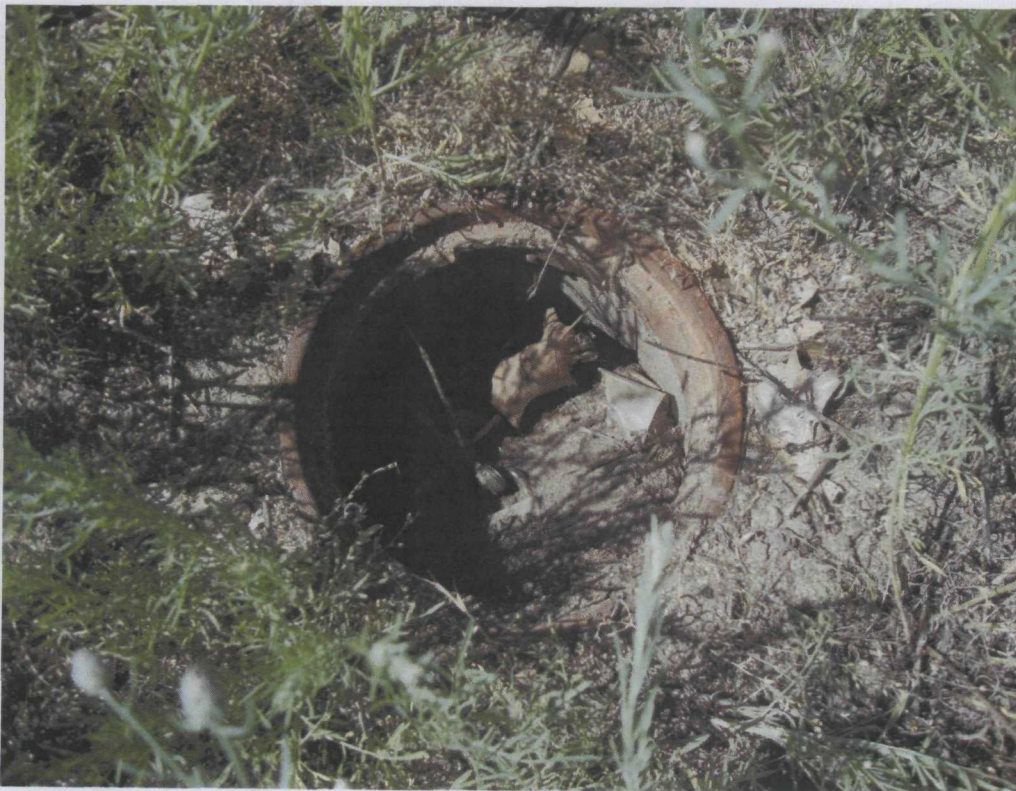
Photo 8: Example of flush monitoring well in poor condition.

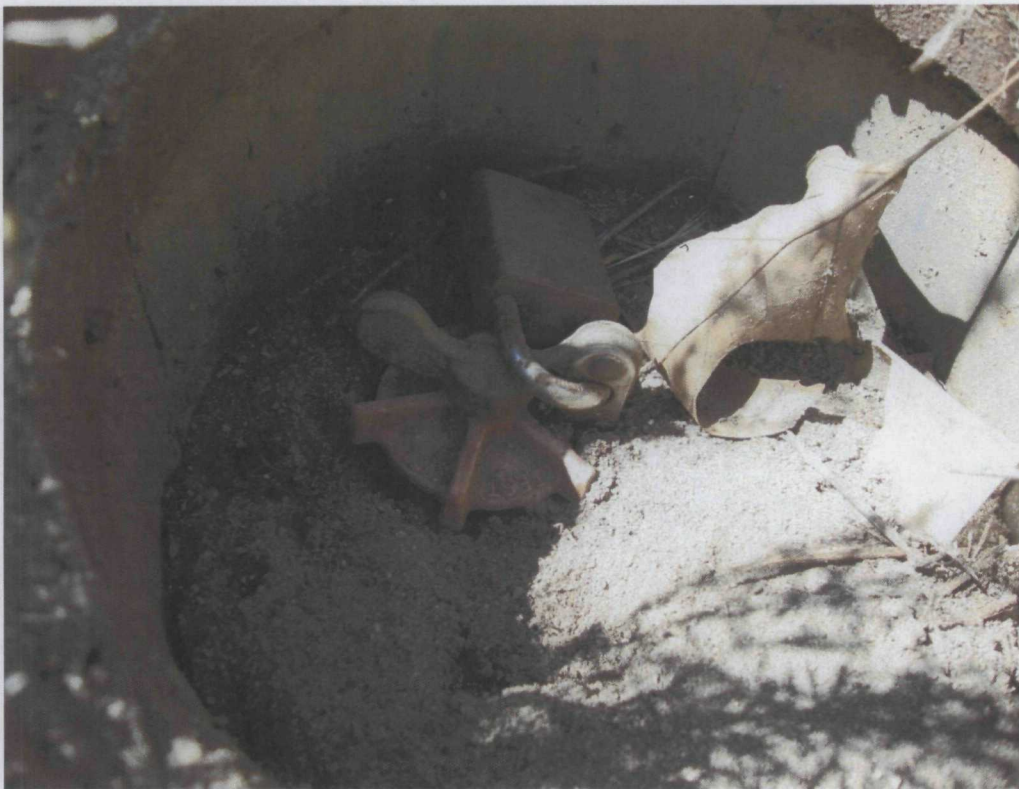
Photo 9: Monitoring well (SW26A) located in meridian of Highway. At first, well appears to be locked.

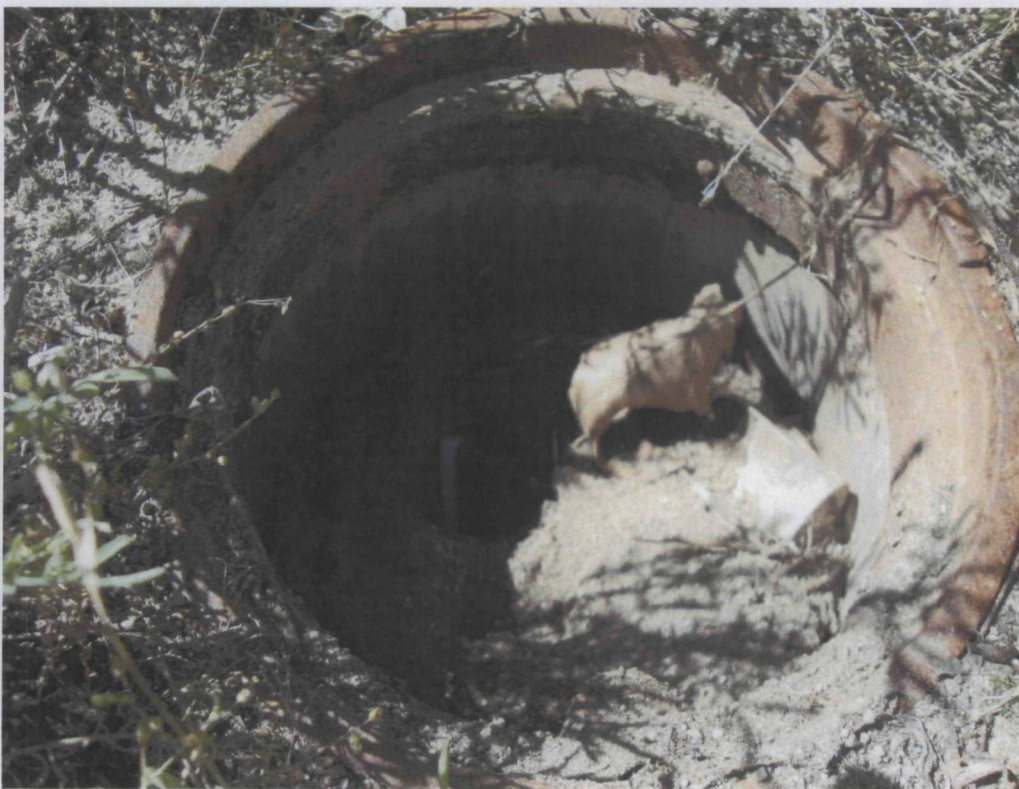
Photo 10: Monitoring well (SW26A), with lock removed from well casing.

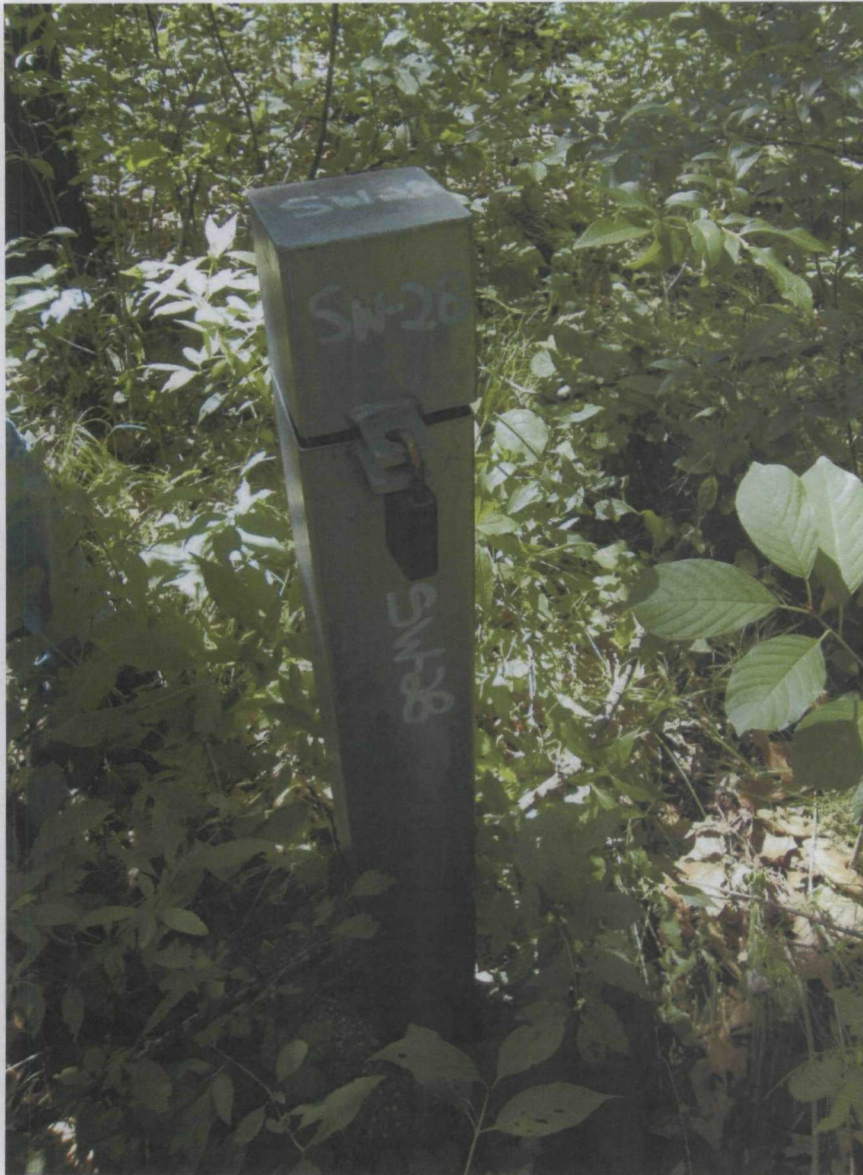
Photo 11: Example of SW-28 Monitoring well in good condition.

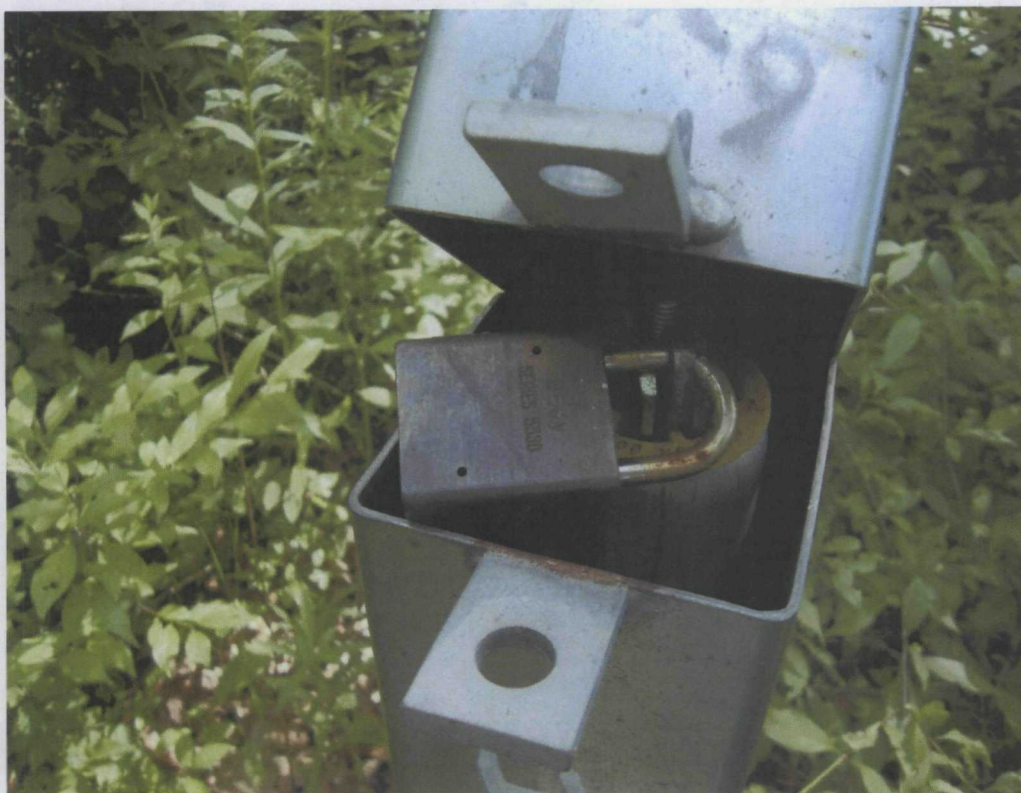
Photo 12: Monitoring well (IW-9) locked, but weld on casing too high to allow for proper closure

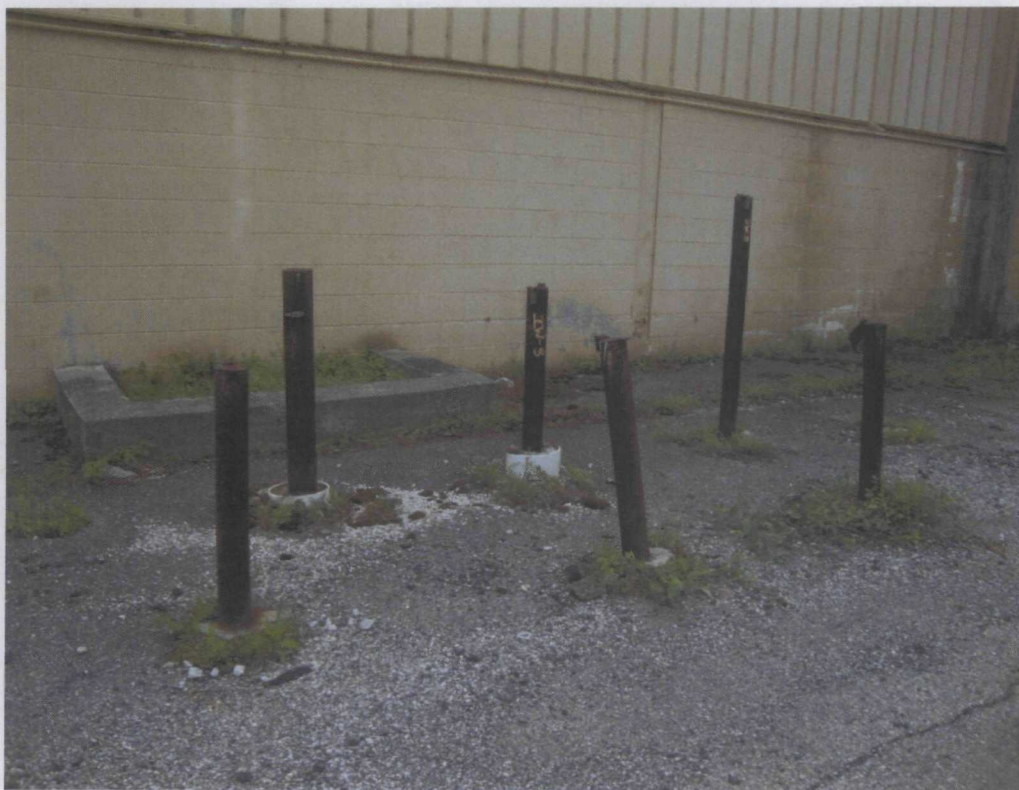
Photo 13: Cluster of monitoring well locations (IW-3, SW-3, SW-21)

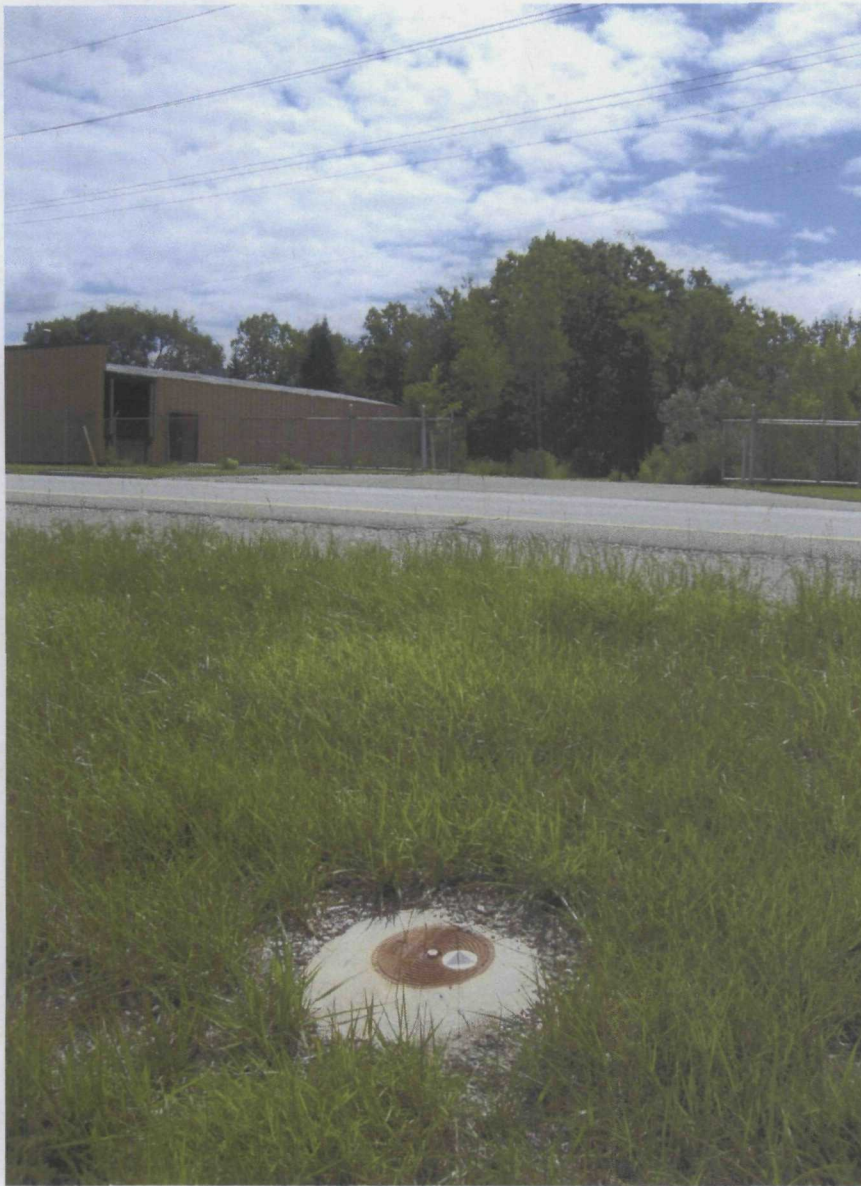
Photo 14: Location of flush mount monitoring well in meridian of Highway.
